# HOME REPORT

48 GIBBON CRESCENT  
EAST KILBRIDE  
GLASGOW  
G74 3HU

# Energy Performance Certificate (EPC)

48 GIBBON CRESCENT, EAST KILBRIDE, GLASGOW, G74 3HU

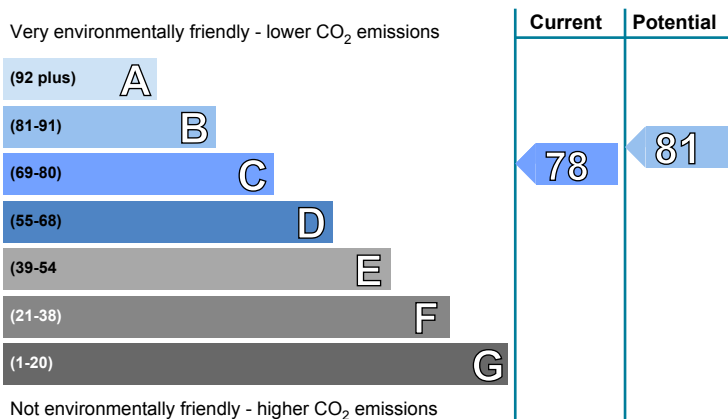
## Environmental Impact (CO<sub>2</sub>) Rating

This graph shows the effect of your home on the environment in terms of carbon dioxide (CO<sub>2</sub>) emissions. The higher the rating, the less impact it has on the environment.

Your current rating is **band C (78)**. The average rating for EPCs in Scotland is **band D (59)**.

The potential rating shows the effect of undertaking all of the improvement measures listed within your recommendations report.
