**HOME**  
report

SINGLE SURVEY  
ENERGY REPORT  
PROPERTY QUESTIONNAIRE  
VALUATION REPORT

# Single Survey

<b>Property Address</b>	7 Oykel Walk Glasgow G33 1FA
<b>Customer</b>	Mrs A Jack & Mr G Jack
<b>Date of Inspection</b>	27/08/2024
<b>Prepared by</b>	Duncan Somerville Harvey Donaldson & Gibson Chartered Surveyors

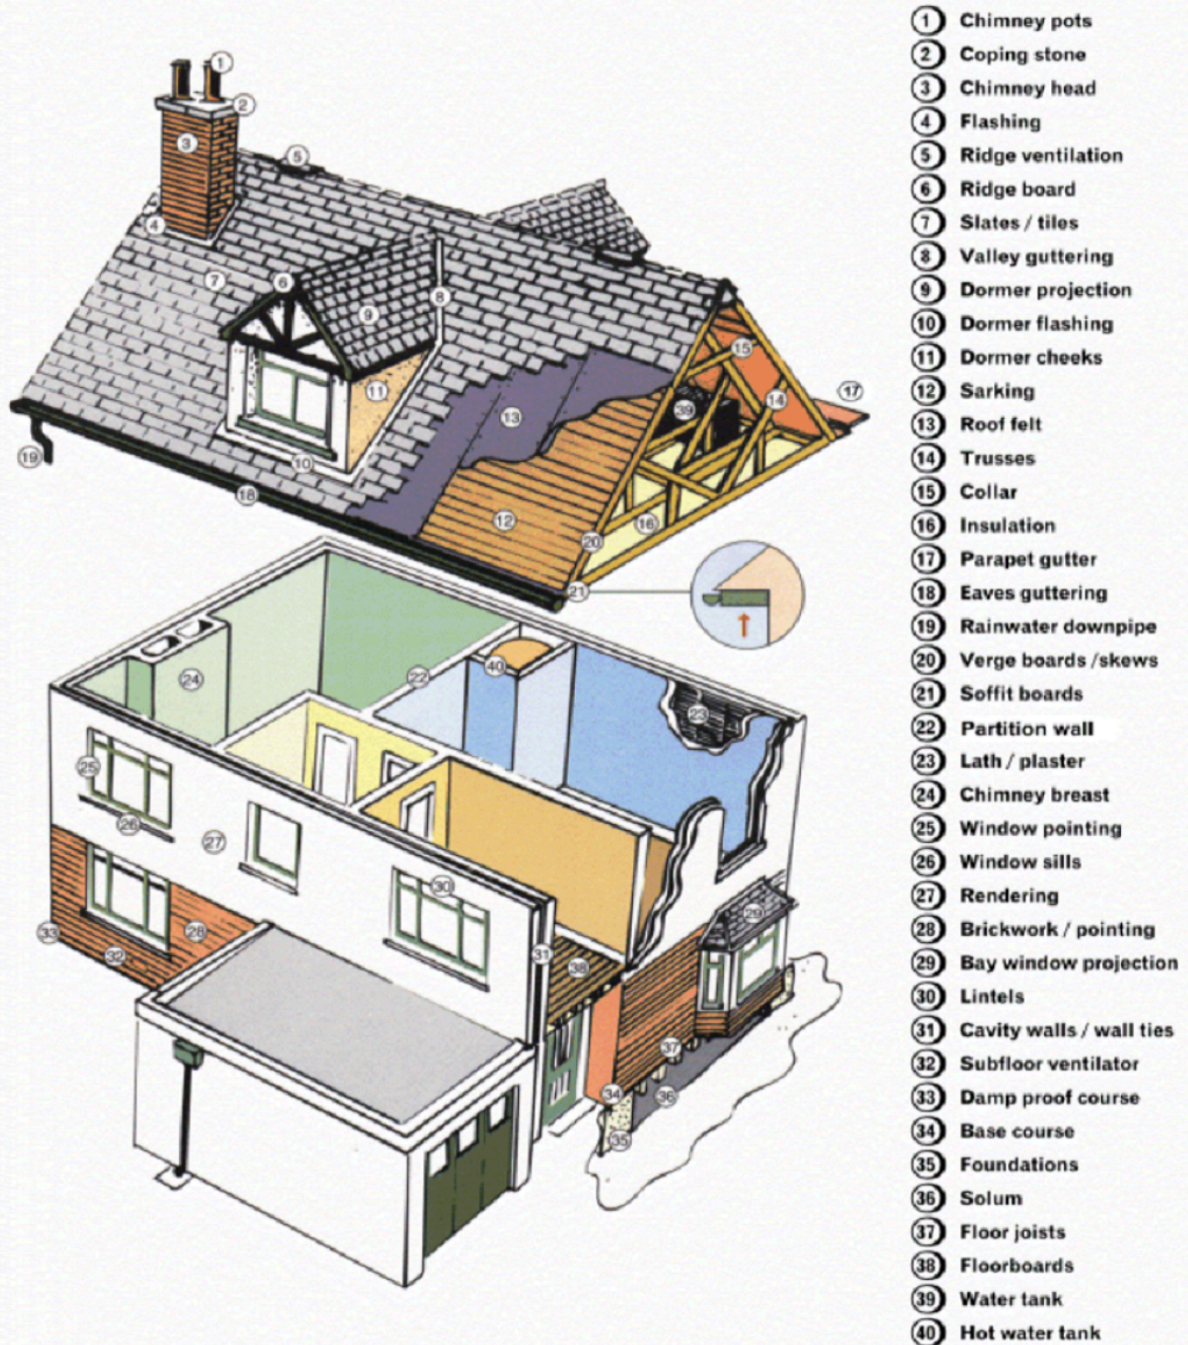
## Sectional Diagram showing elements of a typical house

Reference may be made in this report to some or all of the above component parts of the property. This diagram may assist you in locating and understanding these items.
